APPENDIX D

SITE PHOTOGRAPHS

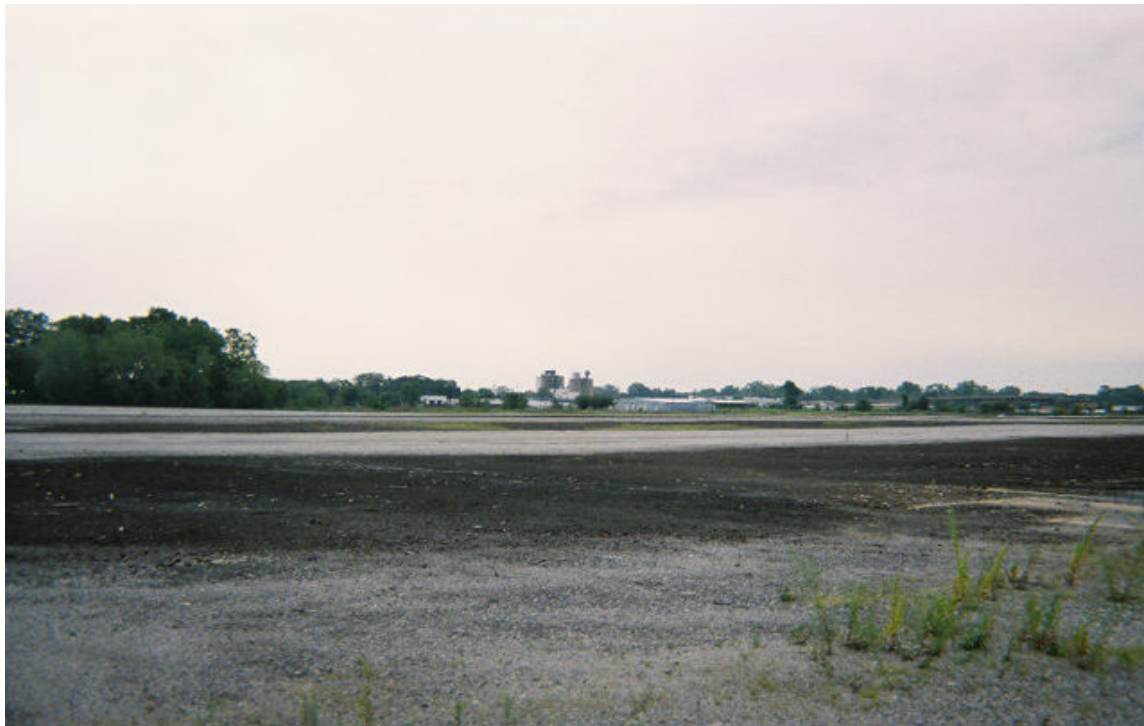
PHOTOGRAPH:		PHOTOGRAPHER:	Melanie Gotto
DATE/TIME:	8/24/2005	9:41 AM	
PROJECT:	Remedial Investigation Report for the Old American Zinc Plant Site, Fairmont City, Illinois		
SUBJECT:	Looking east/southeast toward General Chemical across the Facility. Topography is generally flat and consists of a rotomill and slag mix material.

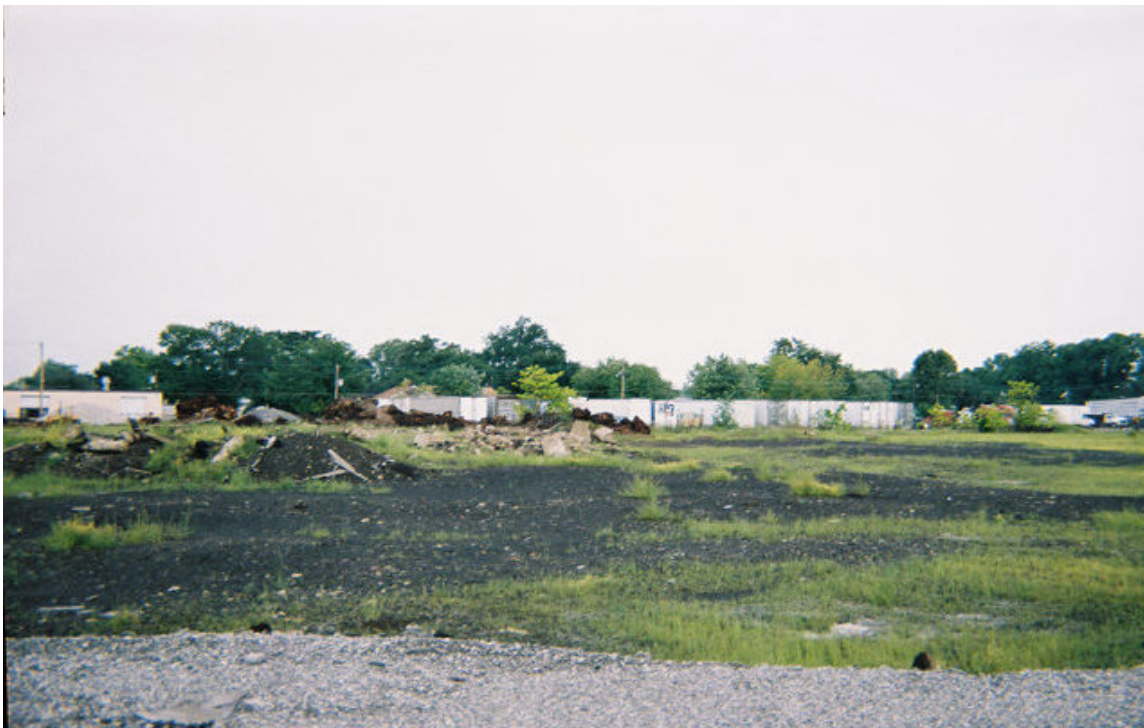
PHOTOGRAPH:		PHOTOGRAPHER:	
DATE/TIME:	8/24/2005	10:41 AM	
PROJECT:	Remedial Investigation Report for the Old American Zinc Plant Site, Fairmont City, Illinois		
SUBJECT:	Looking west across former slag stockpiled area located near the northwest portion of the Facility. Garcia's Trucking is in the background.

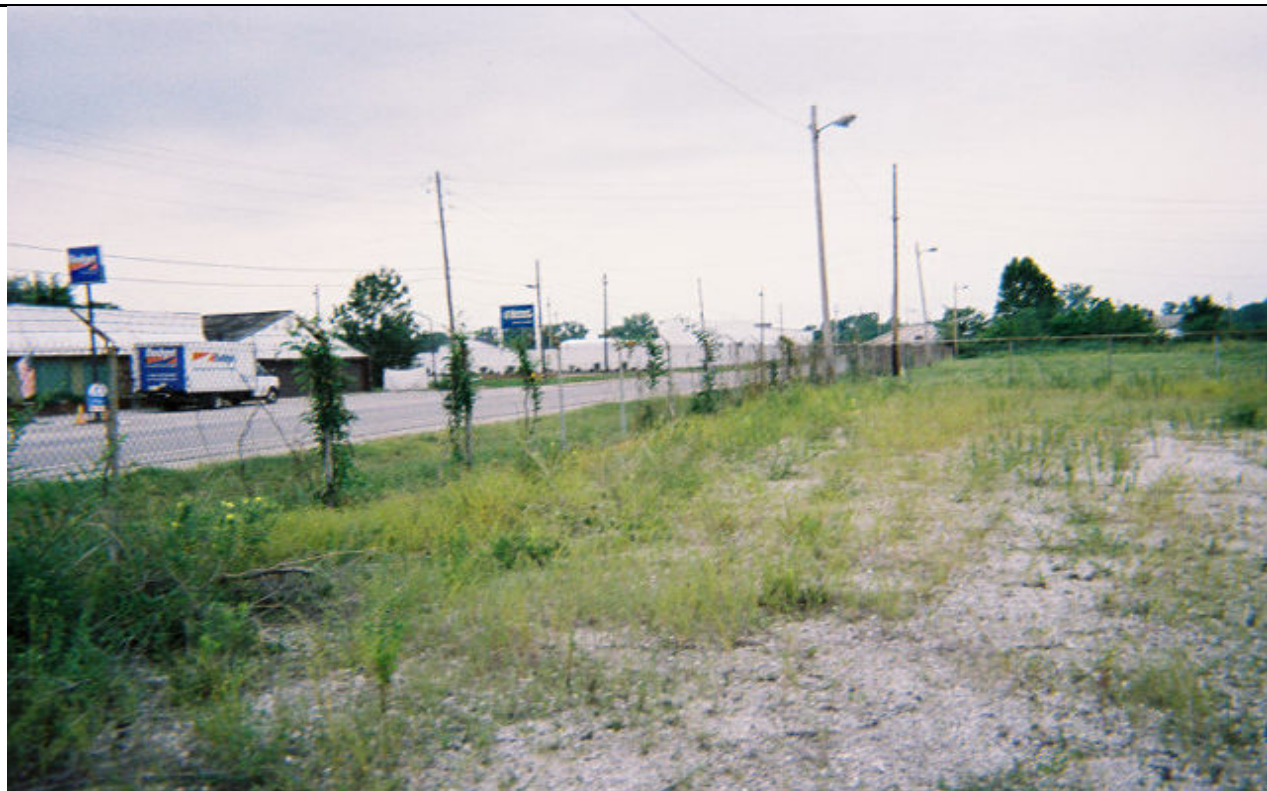
PHOTOGRAPH:		PHOTOGRAPHER:	Melanie Gotto
DATE/TIME:	8/24/2005	9:27 AM	
PROJECT:	Remedial Investigation Report for the Old American Zinc Plant Site, Fairmont City, Illinois		
SUBJECT:	Fenced-in area located on eastern portion of the Facility across Kingshighway and the former Biggs Brothers Service Station

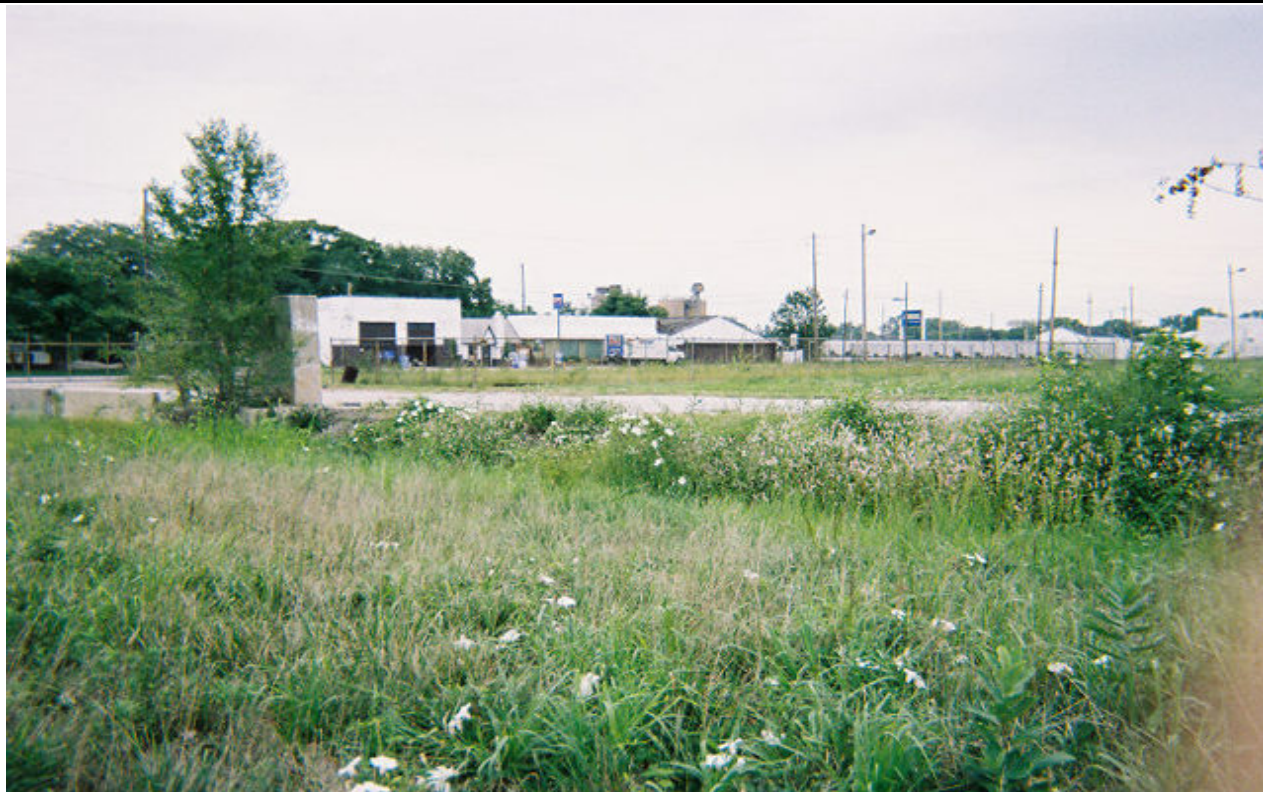
PHOTOGRAPH:		PHOTOGRAPHER:	Melanie Gotto
DATE/TIME:	8/24/2005	9:28 AM	
PROJECT:	Remedial Investigation Report for the Old American Zinc Plant Site, Fairmont City, Illinois		
SUBJECT:	Looking east towards the former Biggs Brothers Service Station and General Chemical Corporation

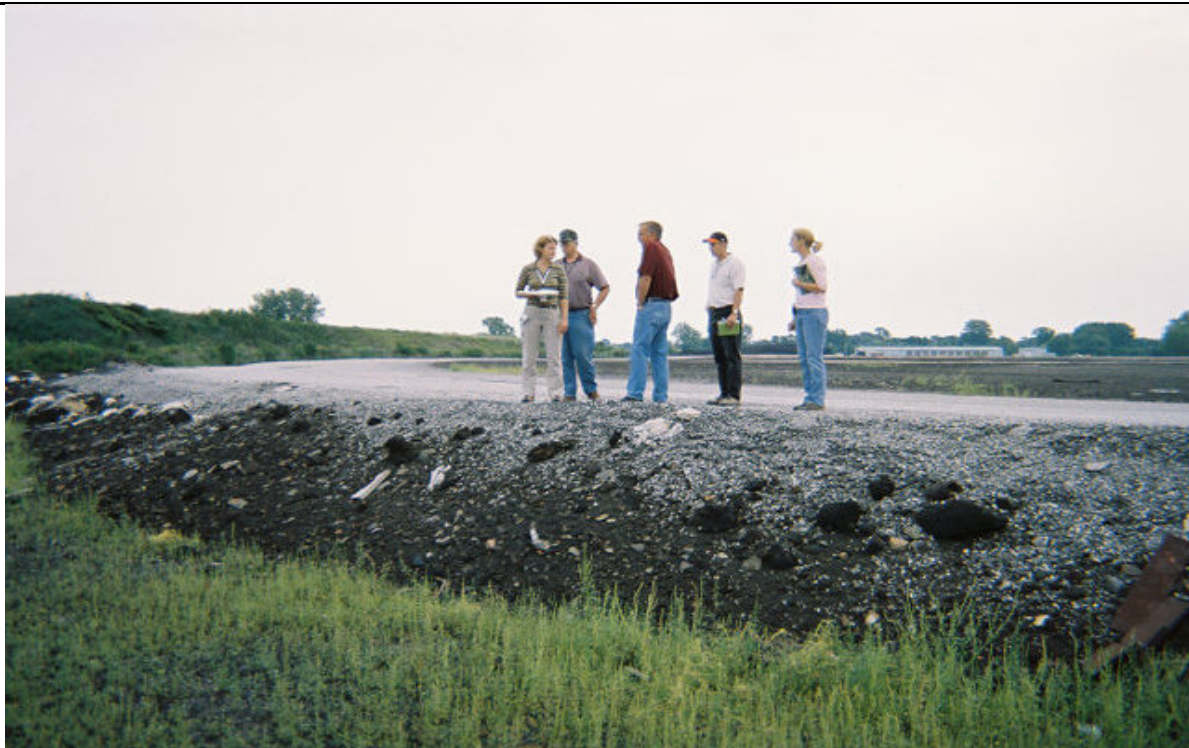
PHOTOGRAPH:		PHOTOGRAPHER:	Melanie Gotto
DATE/TIME:	8/24/2005	9:38 AM	
PROJECT:	Remedial Investigation Report for the Old American Zinc Plant Site, Fairmont City, Illinois		
SUBJECT:	Northwestern portion of the Facility looking at cross-section of access road consisting of mixture of roto-mill and slag.

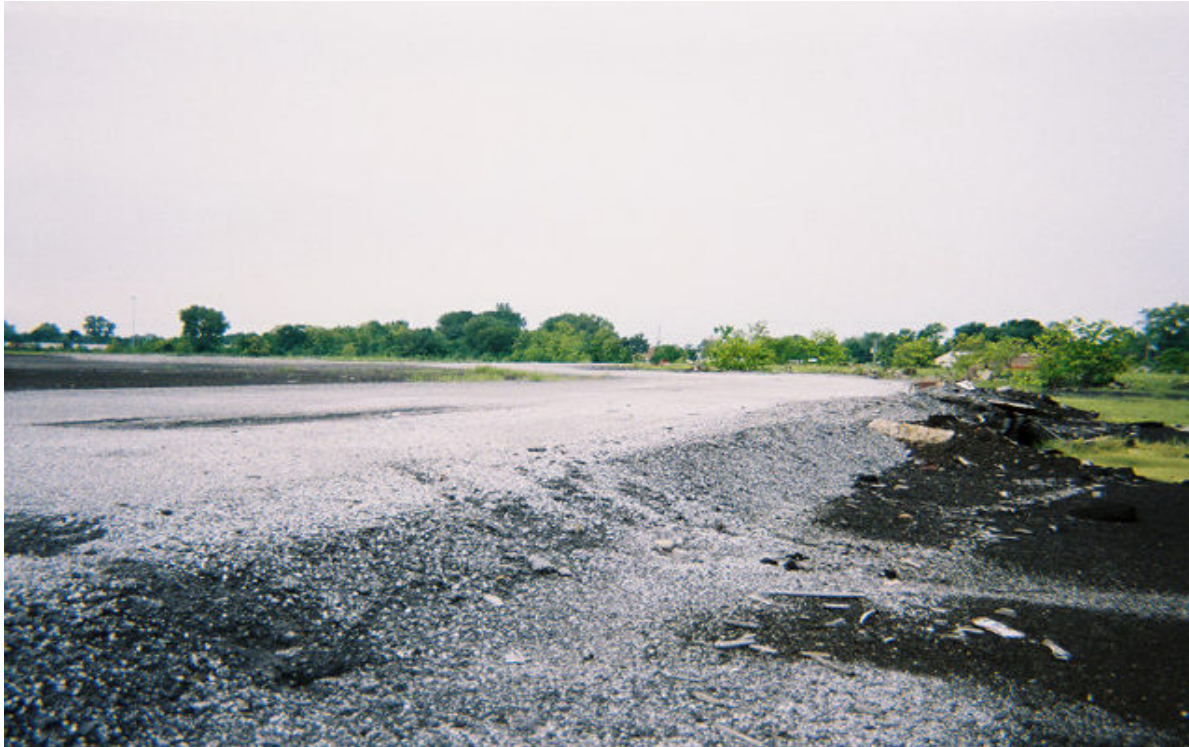
PHOTOGRAPH:		PHOTOGRAPHER:	Melanie Gotto
DATE/TIME:	8/24/2005	9:39 AM	
PROJECT:	Remedial Investigation Report for the Old American Zinc Plant Site, Fairmont City, Illinois		
SUBJECT:	Looking west-southwest from stockpiled slag area at access road elevation containing mixture of slag and roto-mill.

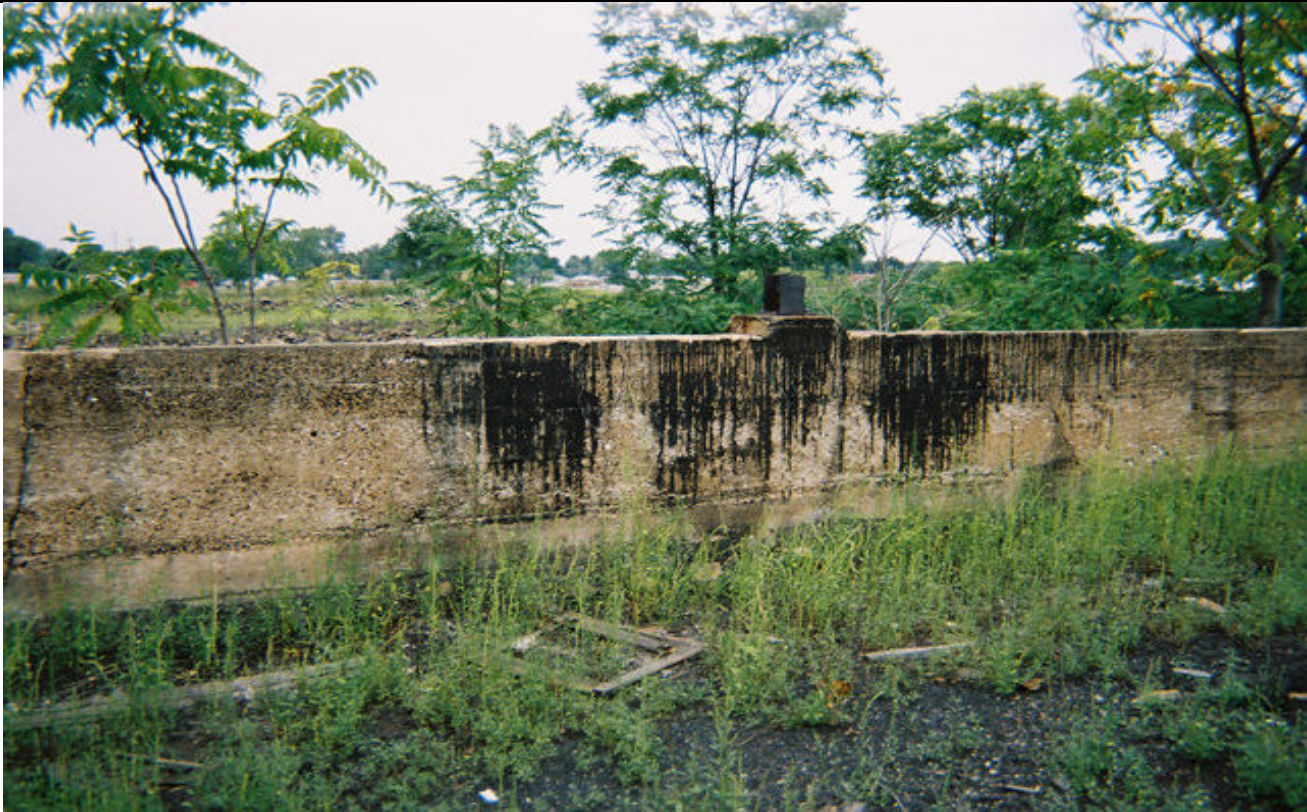
PHOTOGRAPH:		PHOTOGRAPHER:	Melanie L. Luna
DATE/TIME:	8/24/2005 0933		
PROJECT:	Remedial Investigation Report for the Old American Zinc Plant Site, Fairmont City, Illinois		
SUBJECT:	Looking at stained foundation wall associated with historic plant operations.

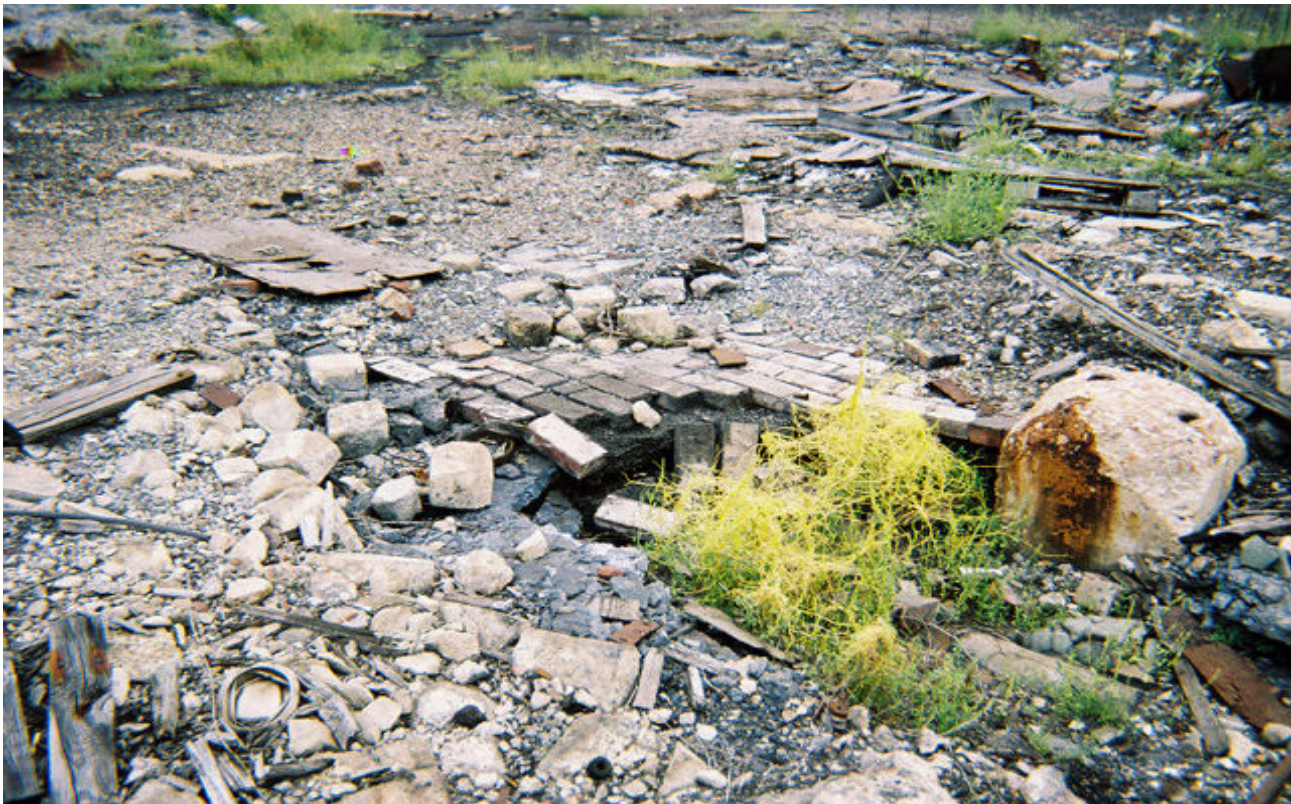
PHOTOGRAPH:		PHOTOGRAPHER:	Melanie L. Luna
DATE/TIME:	8/24/2005 0934		
PROJECT:	Remedial Investigation Report for the Old American Zinc Plant Site, Fairmont City, Illinois		
SUBJECT:	Rubble associated with historic plant operations located in the center of the Facility, west of the historic rail line.

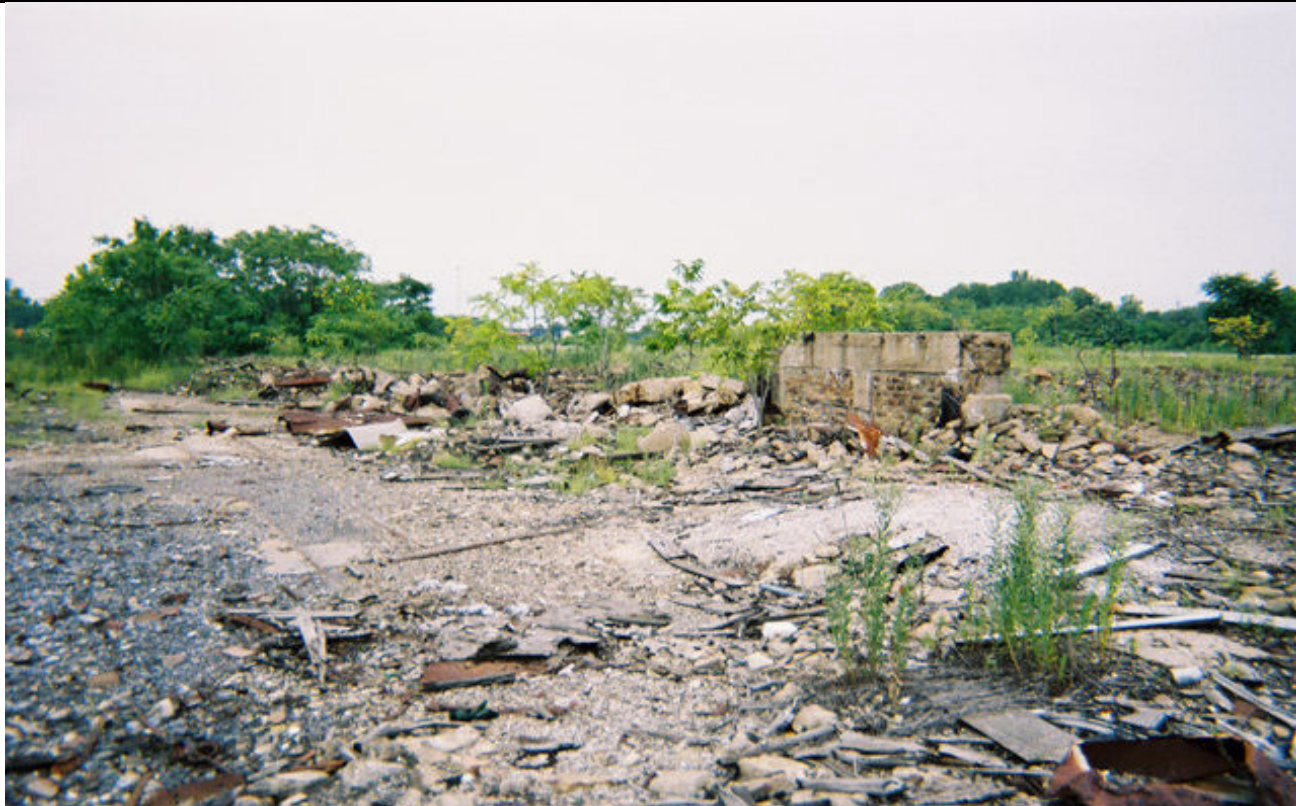
PHOTOGRAPH:		PHOTOGRAPHER:	Melanie Gotto
DATE/TIME:	8/24/2005	9:35 AM	
PROJECT:	Remedial Investigation Report for the Old American Zinc Plant Site, Fairmont City, Illinois		
SUBJECT:	Rubble associated with historic plant operations located in the center of the Facility, west of the historic rail line.

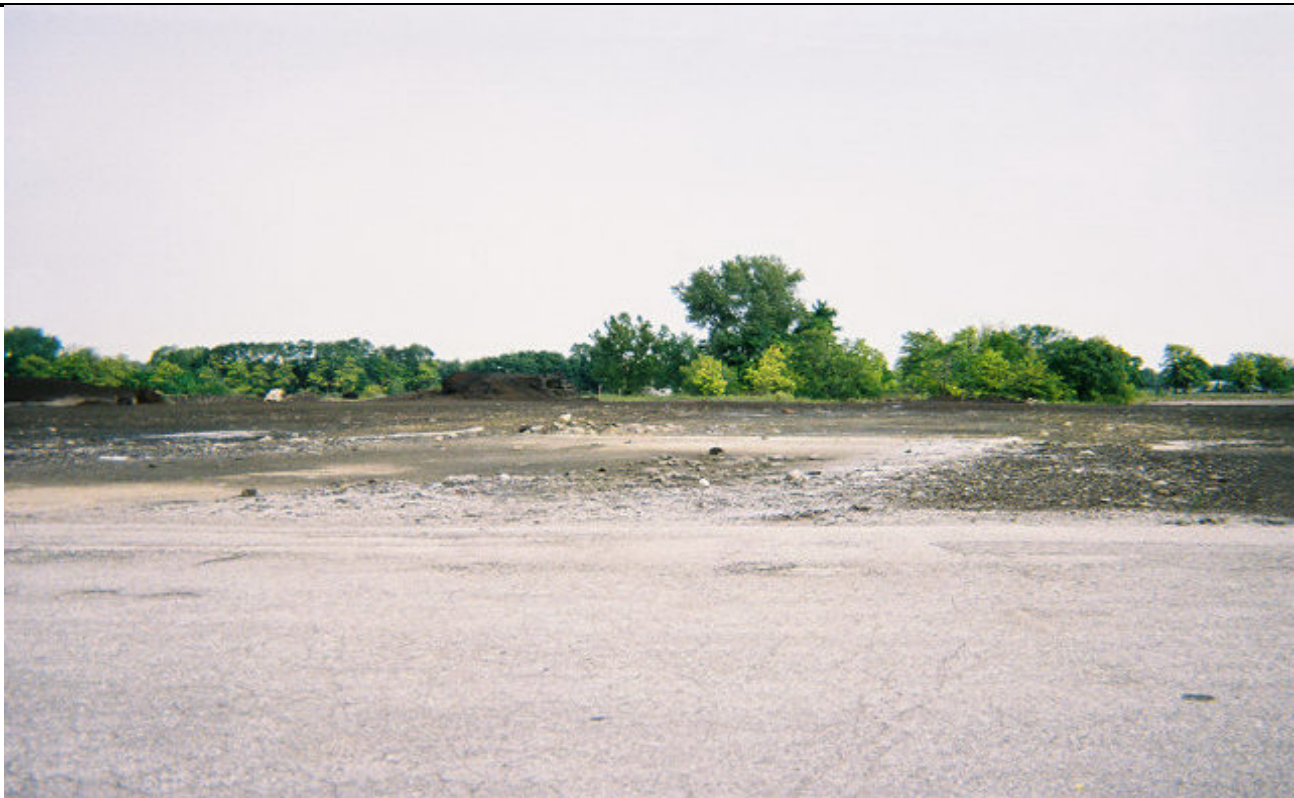
PHOTOGRAPH:		PHOTOGRAPHER:	Melanie Gotto
DATE/TIME:	8/24/2005	9:43 AM	
PROJECT:	Remedial Investigation Report for the Old American Zinc Plant Site, Fairmont City, Illinois		
SUBJECT:	Looking north toward former building footprint and slag pile in background.

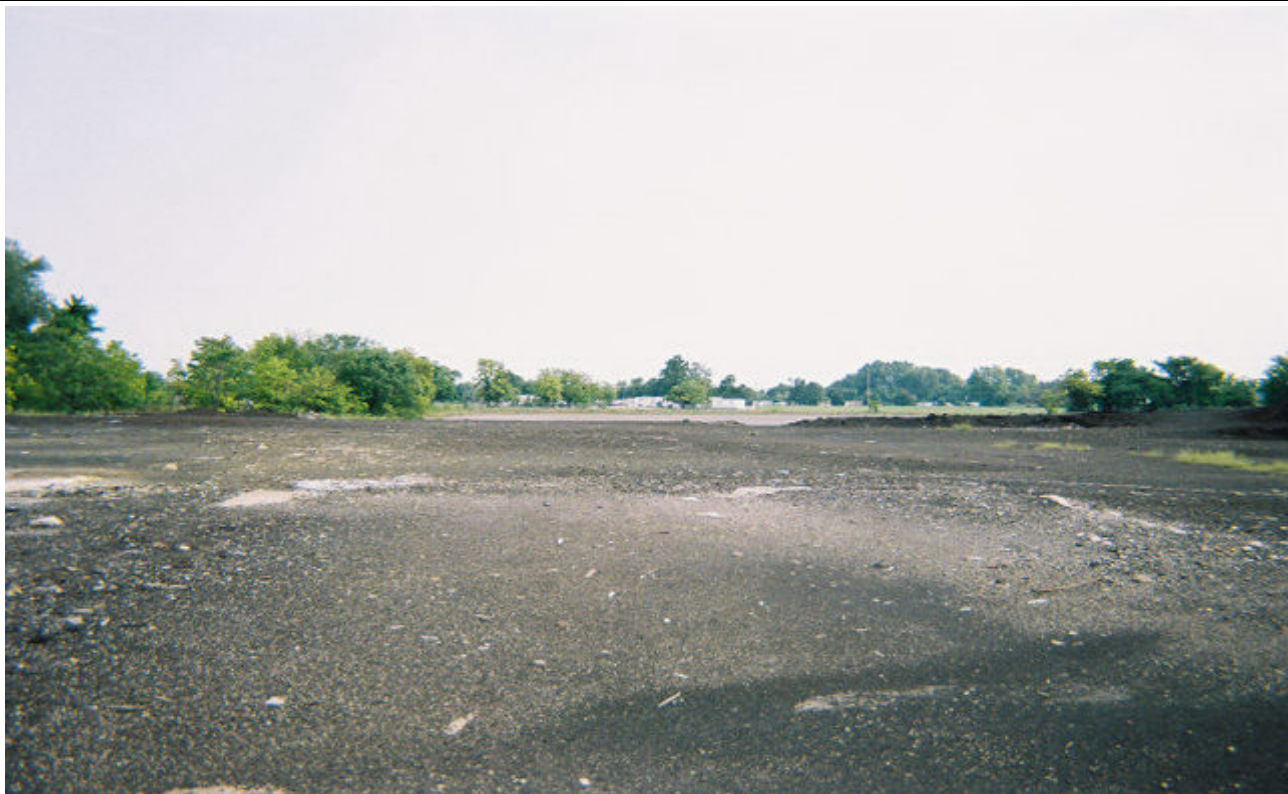
PHOTOGRAPH:		PHOTOGRAPHER:	Melanie Gotto
DATE/TIME:	8/24/2005	9:44 AM	
PROJECT:	Remedial Investigation Report for the Old American Zinc Plant Site, Fairmont City, Illinois		
SUBJECT:	Looking toward low-lying, unvegetated area located north of stockpiled slag area adjacent to Maryland Parkway in Grids 39 and 40.

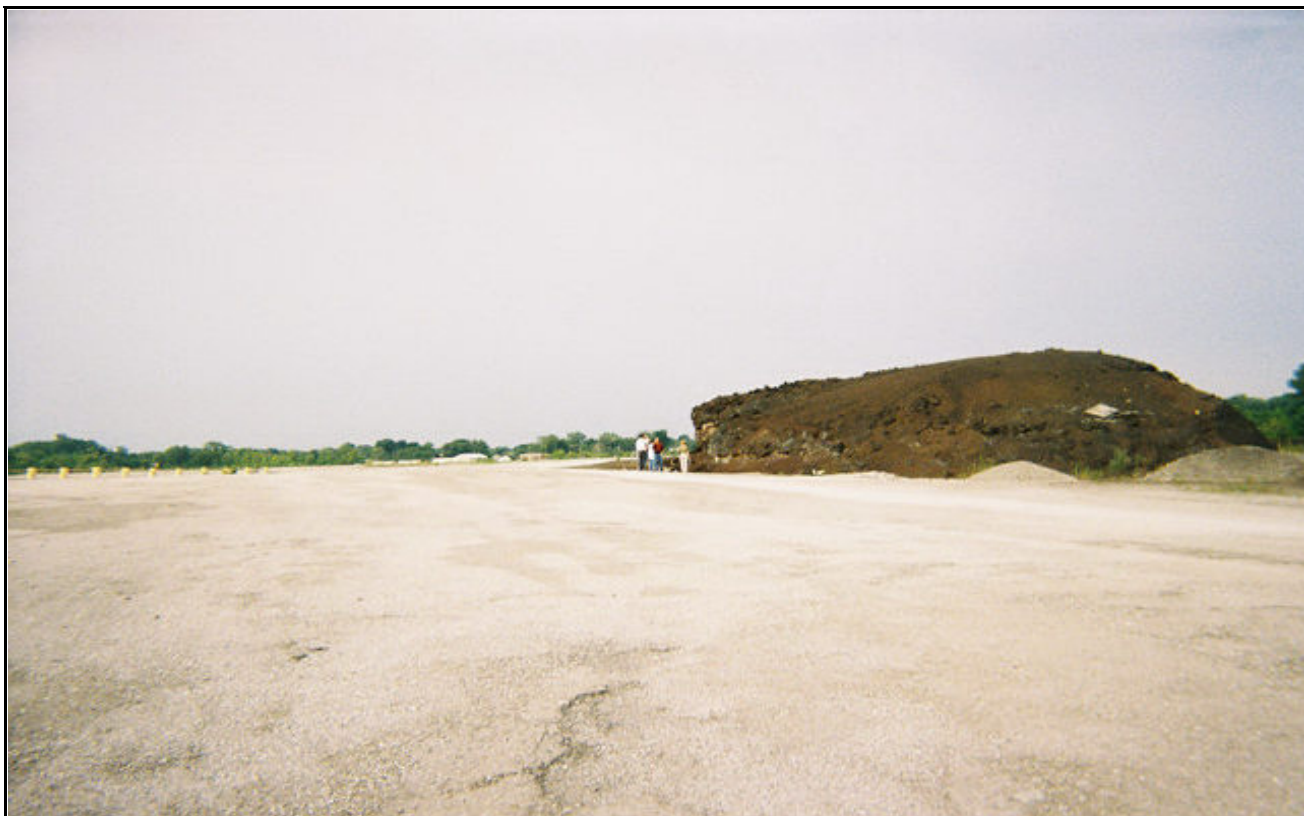
PHOTOGRAPH:		PHOTOGRAPHER:	Melanie Gotto
DATE/TIME:	8/24/2005	9:15 AM	
PROJECT:	Remedial Investigation Report for the Old American Zinc Plant Site, Fairmont City, Illinois		
SUBJECT:	Slag pile located on northern portion of the Facility in relation to a six-foot person.

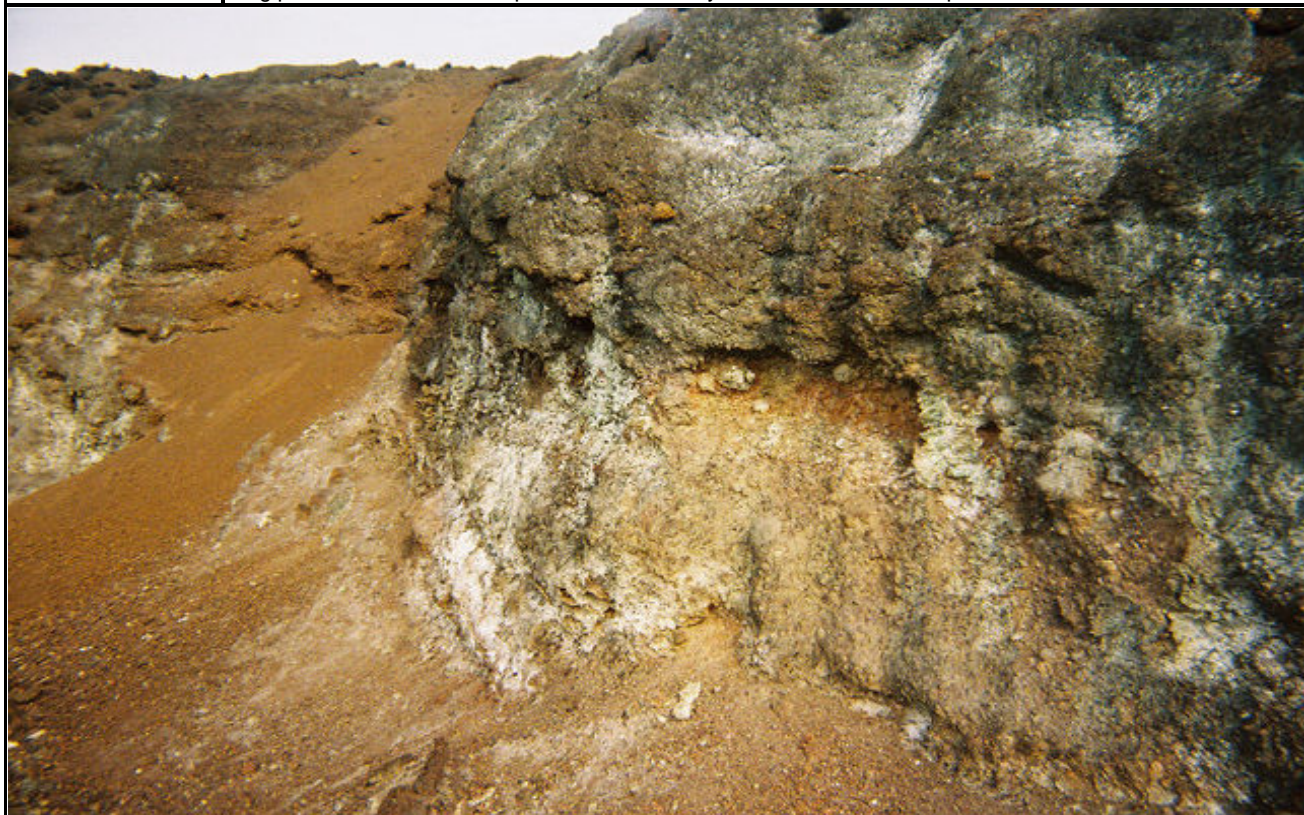
PHOTOGRAPH:		PHOTOGRAPHER:	Melanie Gotto
DATE/TIME:	8/24/2005	9:15 AM	
PROJECT:	Remedial Investigation Report for the Old American Zinc Plant Site, Fairmont City, Illinois		
SUBJECT:	Close up cross section of slag pile located on northern portion of Facility.

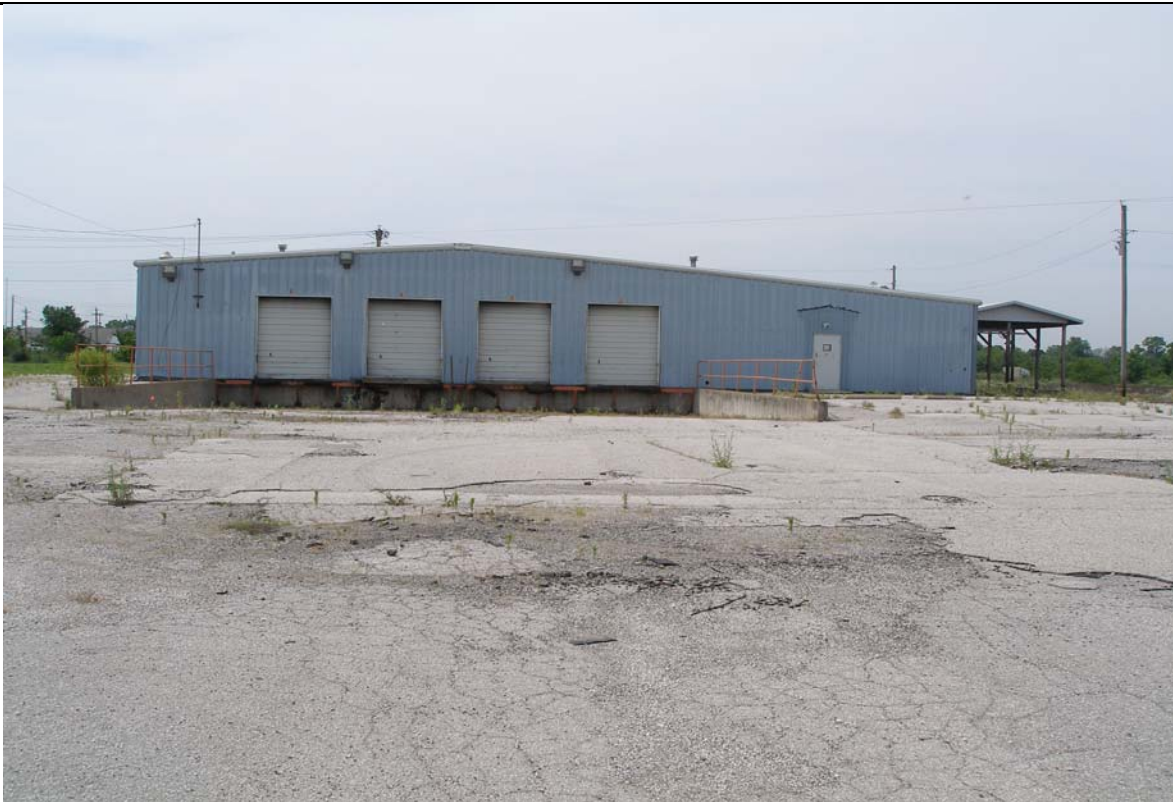
PHOTOGRAPH:		PHOTOGRAPHER:	Melanie Gotto
DATE/TIME:	6/8/2006	11:18 AM	
PROJECT:	Remedial Investigation Report for the Old American Zinc Plant Site, Fairmont City, Illinois		
SUBJECT:	Interstate Tire Retread, Inc. building located near the southeastern portion of the Facility in Grids 70 and 71.

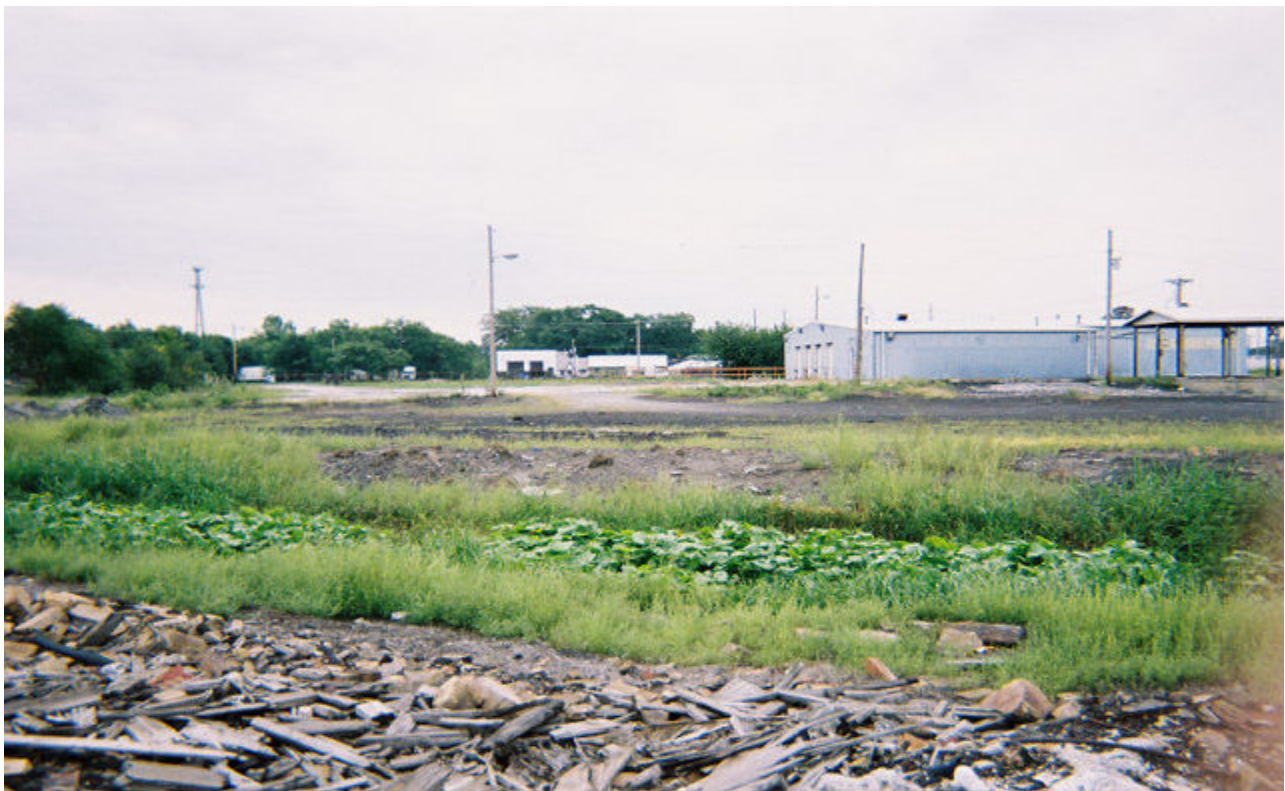
PHOTOGRAPH:		PHOTOGRAPHER:	Melanie Gotto
DATE/TIME:	8/24/2005	9:29 AM	
PROJECT:	Remedial Investigation Report for the Old American Zinc Plant Site, Fairmont City, Illinois		
SUBJECT:	Looking south toward Interstate Tire Retread, Inc. across East Ditch 1. Rubble from historic ore and maintenance buildings in foreground.

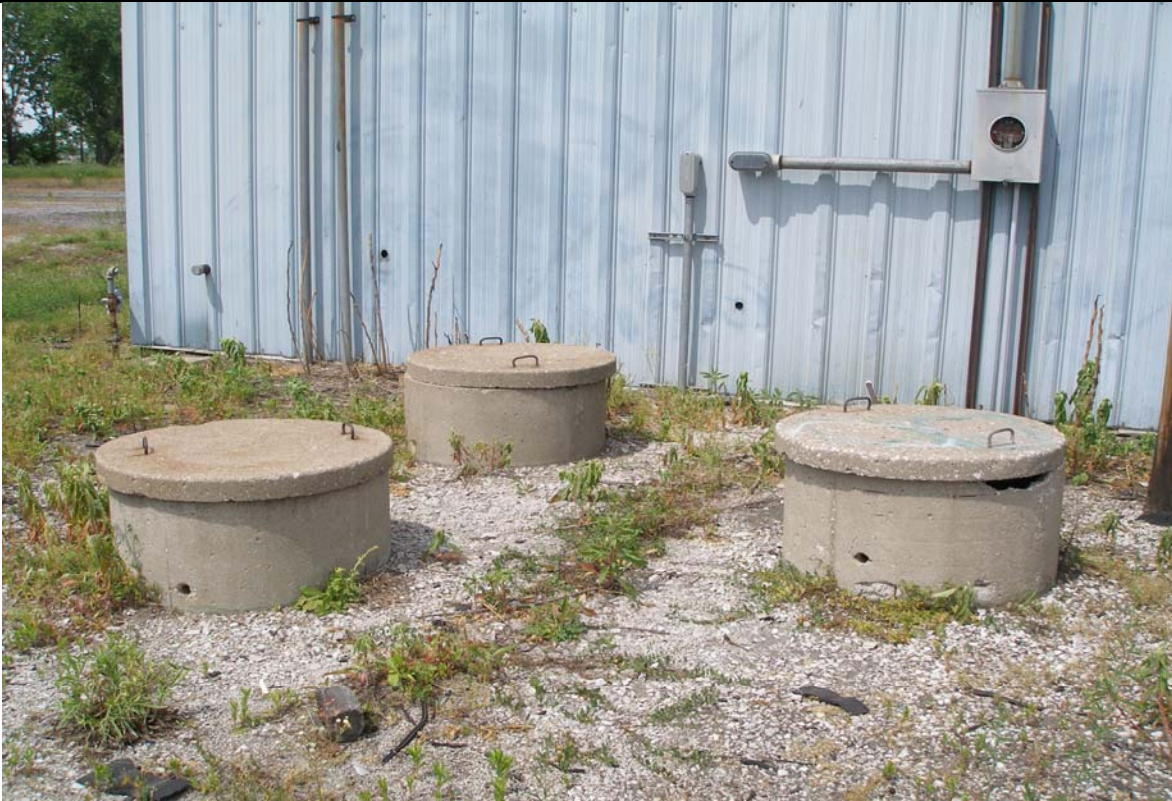
PHOTOGRAPH:		PHOTOGRAPHER:	Melanie Gotto
DATE/TIME:	6/8/2006	11:07 AM	
PROJECT:	Remedial Investigation Report for the Old American Zinc Plant Site, Fairmont City, Illinois		
SUBJECT:	Three concrete vaults located adjacent to XTRA's former machine shop in Grid 67.

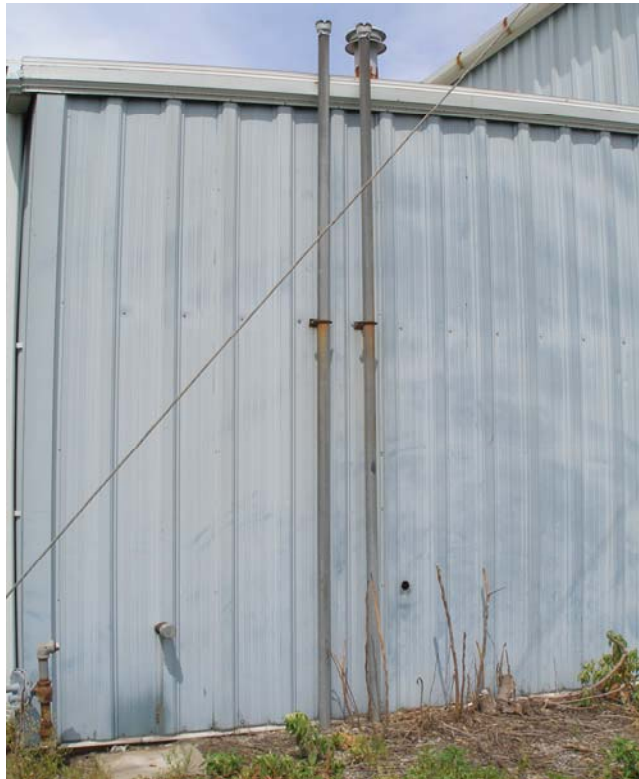
PHOTOGRAPH:		PHOTOGRAPHER:	Jeff Stofferahn
DATE/TIME:	6/8/2006	11:07 AM	
PROJECT:	Remedial Investigation Report for the Old American Zinc Plant Site, Fairmont City, Illinois		
SUBJECT:	Vent pipes attached to XTRA's former shop building, adjacent to the concrete vault area in Grid 67.

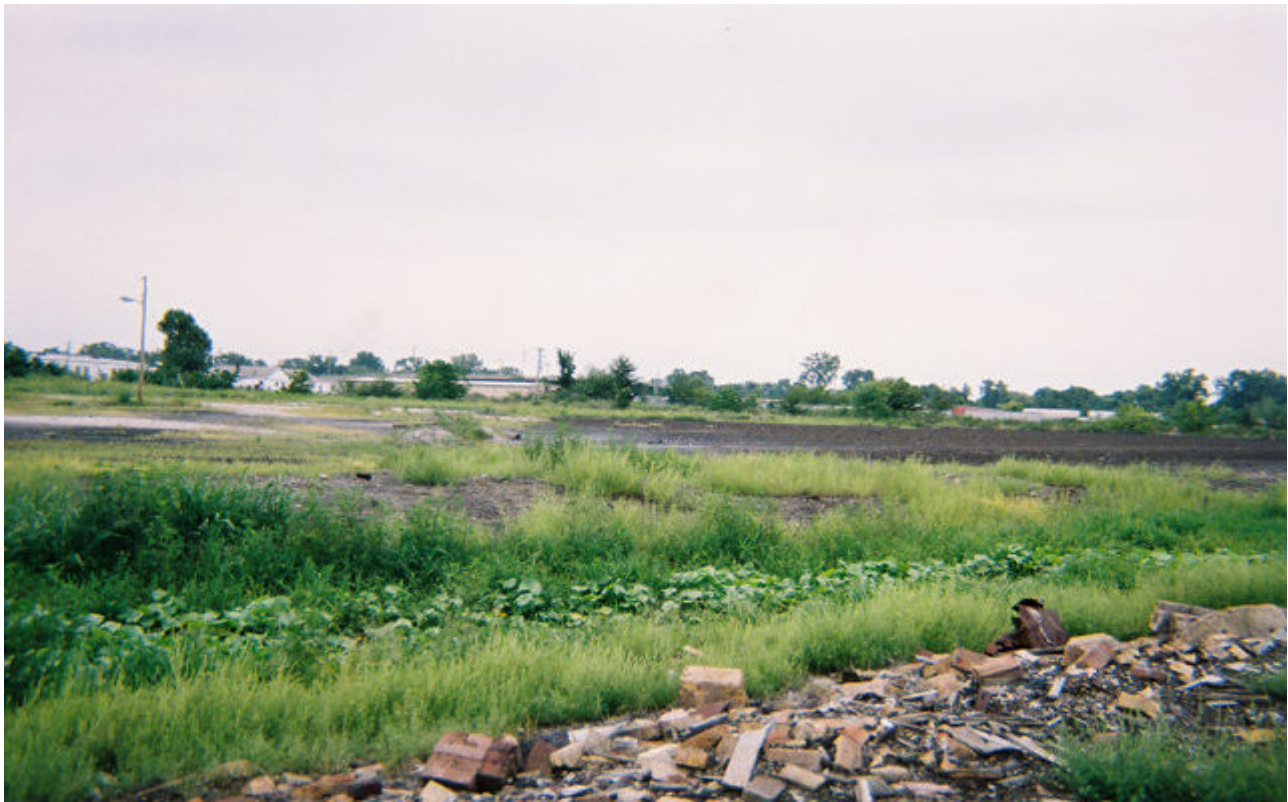
PHOTOGRAPH:		PHOTOGRAPHER:	Melanie Gotto
DATE/TIME:	8/24/2005	9:30 AM	
PROJECT:	Remedial Investigation Report for the Old American Zinc Plant Site, Fairmont City, Illinois		
SUBJECT:	Looking south across East Ditch 1. Cargill Company (formerly Swift Agricultural Chemical Corp.) is visible in background.
